WEATHERING

ABOUT ACCOYA®

UNCOATED ACCOYA®

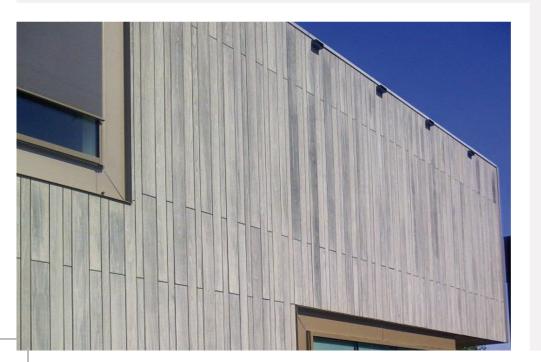
An example of such a blotchy transition period is shown in the image above (Dutch cladding project approximately a year after installation).

However, prior to turning grey, uncoated Accoya® will go through a phase of bleaching where it turns a lighter shade of its normal colour. Surface growths are particularly apparent in this intervening period and can vary in level from board to board. This will become less distinguishable and objectionable after full (even) greying, but in this transition period the surface of Accoya® may look blotchy.

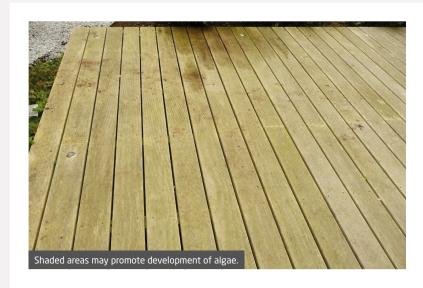
A wet and a dry board may vary in appearance. Due to the installation details, the presence of a shaded area and the natural differences in the wood between boards, as for instance density variation or grain orientation, some may dry quicker than others.

Not only does this reflect on the appearance of a surface while drying, it will also have an influence on the development of moulds, algae and so on.

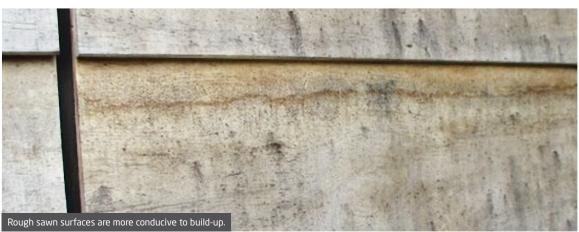
While these surface growths do not cause decay themselves, they are often associated with the beginning of fungal decay of wood. However, on the non-toxic surface of Accoya® surface moulds may grow, but there will be no concurrent beginning of rot, that might affect its intergity.

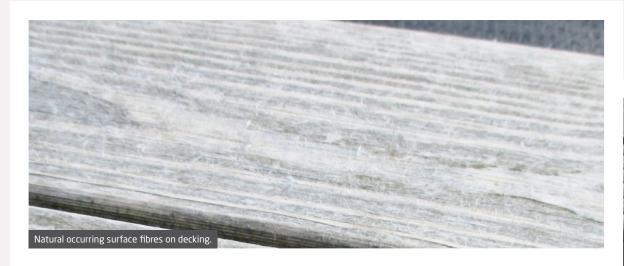
The higher the amount or intensity of UV the surface is subject to, the faster this process will develop. It should be noted that these fibres are formed on all exposed wood species, including Accoya®, particularly on flat surfaces like decking. A ribbed deck profile will tend to cause an accumulation of these fibres, making it all the more noticeable.

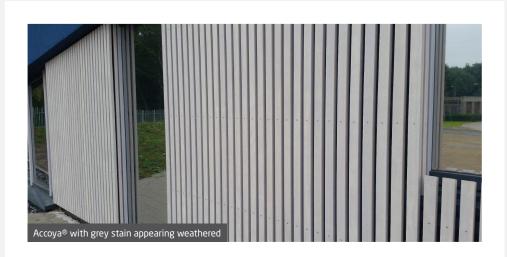
Applying a grey stain can give a weathered appearance from the installation of the project, as depicted above.

In case of a vertical application as cladding, a film-forming system will be more resilient than a stain or a semi-film forming system. When using an opaque base coat, preferably an effective and well applied anti stain blocking primer is to be included.
